ECOLOGY AND PROTECTED SPECIES SURVEY
CHAPELS AND GROUNDS AT PARK ROAD CEMETERY,
HOLBEACH, LINCOLNSHIRE

NOVEMBER 2016

Scarborough Nixon

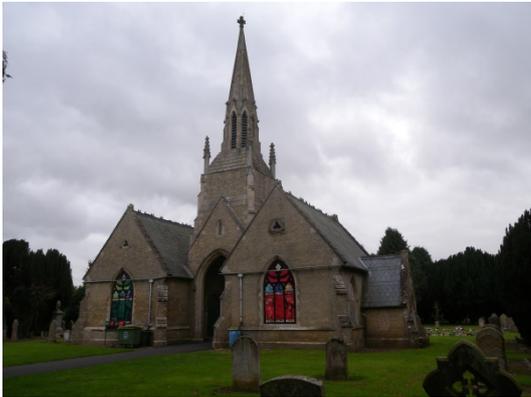
The site comprises two identical chapel buildings (north and south), which are connected by an arch which supports a bell tower. There are also small porches on the north and south elevations. The building is constructed of solid stone walls supporting a pitched timber roof covered with slates. There are a small number of lifted slates on the chapels, and a slipped slate on the northern elevation, with a reasonable sized gap underneath. The large windows of the chapels have been boarded over whilst smaller roundel windows have fine wire mesh over them. There is a small gap above a boarded up window on the southern elevation of the chapel. Generally the stonework is tight and there were few gaps seen. There are some small gaps at the eaves level where the timbers meet the stonework, and a crack in the stonework was noted on the western elevation. There are some small gaps under lifted lead flashing on the northern porch.

Photograph 2: The chapels

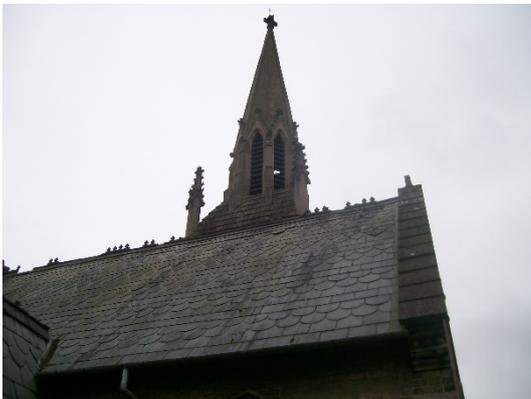
Photograph 4: Slipped and lifted slate on northern chapel

During the internal inspection of the buildings a single fresh dropping recalling those voided by brown long-eared bats *Plecotus auritus* was noted in the southern chapel. Generally there were few potential access points into the building, and there were few potential roosting features seen on the exterior of the building. There are some lifted tiles on the roof of the

chapel, which offer potential access points into the small roof voids of the building. These voids are inaccessible, and the tower of the chapels could not be inspected due to health and safety reasons. The chapel buildings are considered to offer moderate potential for long term roosting by bats.

- All gaps within the stonework of the chapels should be checked for roosting by a suitable licensed ecologist if they are to be filled in. This may require the use of an endoscope and mirrors. The gaps should be checked immediately before they are filled in.

- If any works are planned for the roofing of the chapels, an ecologist will be present when the work to strip the roof covering from the chapels commences.

- It may be necessary to put in place replacement access points for bats into the new roof covering, to allow continued use by roosting bats of the small loft void within the chapels. Details of such access points will be determined on site by the ecologist and contractor.

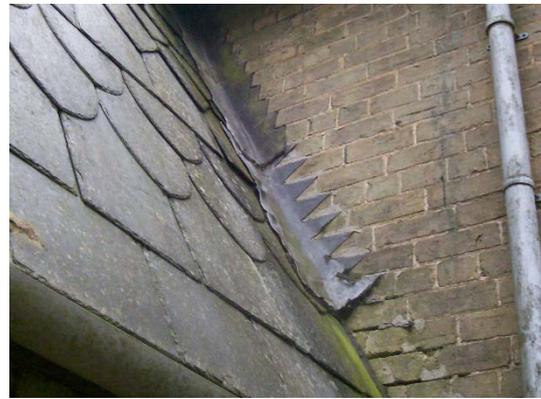
Photograph 5: Lifted tile and gap under lead flashing

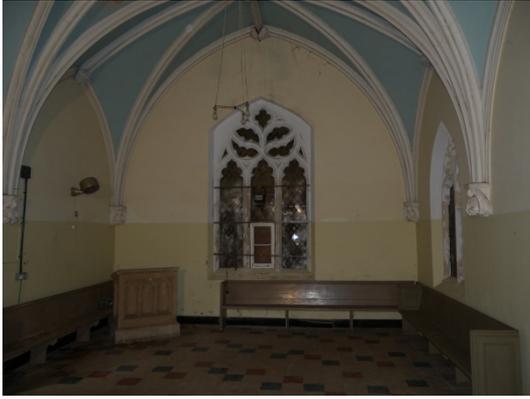
The internal ceilings are vaulted whilst the roof is pitched leaving a small inaccessible gap between the two. The southern chapel is in better order than the northern one which has had most of the plaster removed.

Photograph 6: Interior view of the southern chapel

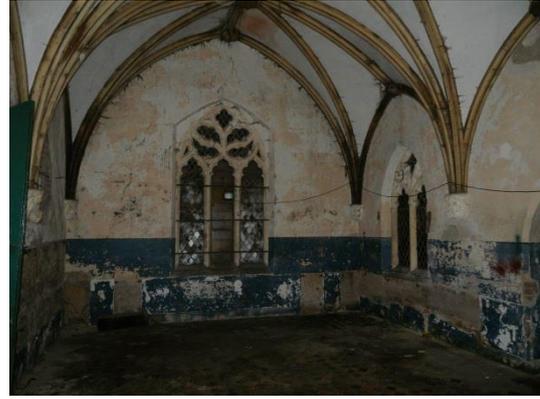
Photograph 7: Interior view of the northern chapel

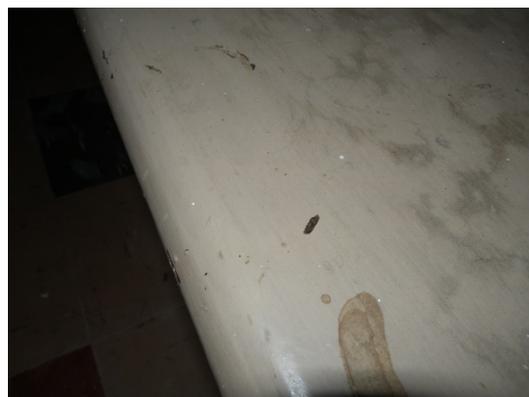
Photograph 8: Brown long-eared dropping found in the southern chapel

It is recommended that precautionary working practices for bats are followed to ensure that bats are not disturbed during the works to restore the buildings.
